RE: Request for Information ("RFI") Pursuant to Section 308 of the Clean Water Act
Compliance Evaluation Inspection Report for CEI conducted on April 4, 2016 at
Jersey Core Supply, Inc.
Docket No. CWA-IR-17-007

COMPLIANCE EVALUATION INSPECTION REPORT

Compliance Evaluation Inspection: Jersey Core Supply Inc.
Inspection Date: April 4, 2016 Inspection Time: 8:15AM – 9:35PM
EPA Inspector: Cyndy S. Kopitsky, Environmental Scientist, USEPA Region 2, DECA, Water Compliance Branch (212) 637-3832 & Andrew Dinsmore, Stormwater Team Leader USEPA Region 3 (215) 814-2788
NJDEP Representative: Sandy Crowley, 609-439-9537
On-Site Representative: Mr. Steve Locilento, 856-365-2020
Site Information: Jersey Core Supply Inc. 635 Jackson Street Camden, New Jersey 08105 Owner/Operator/Permittee: Jersey Core Supply Inc. 635 Jackson Street Camden, New Jersey 08105 Lat. 39.925215, Long. -75.117214 SPDES No. NJG0155233

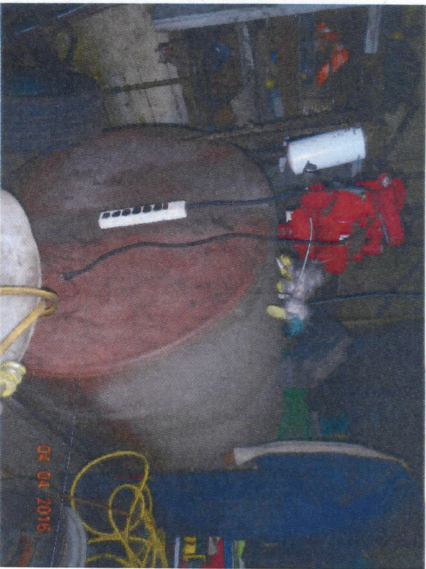
As required by IV.C.5.a-d., all drained fluid shall be stored in a designated fluid storage area. This area shall be either: 1) indoors, or 2) on an impervious surface (e.g. concrete pad) that is contained (e.g. bermed) and under cover. A dedicated spill kit shall be kept in this area. All drained fluid shall be placed in leak-proof containers with secondary containment and shall be labeled for easy identification of contents. At the time of the inspection, vehicle fluids were stored in various containers and placed directly on the ground uncovered, there was no secondary containment for the fuel tanks, and there was oil on the ground around the oil containers therefore in violation of IV.C.5.a-d. of the permit as seen in photo DSCN6976.

DSCN6976	Storage Fuel Tank
DSCN6978	Cylinders Inside Storage area
DSCN6979	Cylinders Inside Storage area
DSCN6980	Equipment and part storage
DSCN6982	Storage under part coverage
DSCN6983	Storage under part coverage
DSCN6984	Leak fuel spill area
DSCN6985	Oil storage-uncovered buckets
DSCN6986	Spill-part speedy dry
DSCN6987	Inside storage
DSCN6988	Inside storage
DSCN6989	Inside storage
DSCN6990	Drum and engine part storage
DSCN6991	Fuel tank
DSCN6992	Auto parts
DSCN6994	Loading dock-rear of facility
DSCN6995	Rear of facility
DSCN6996	Loading dock
DSCN6997	Loading dock standing water
DSCN6998	Open dumpster
DSCN6999	Rear of facility
DSCN7000	Metal parts/scrap
DSCN7001	Rear of facility
DSCN7002	Surface oily staining/partial speedy dry
DSCN7003	Underground storage tank certificate
DSCN7004	2005 BMP form
DSCN7005	1999 Permit

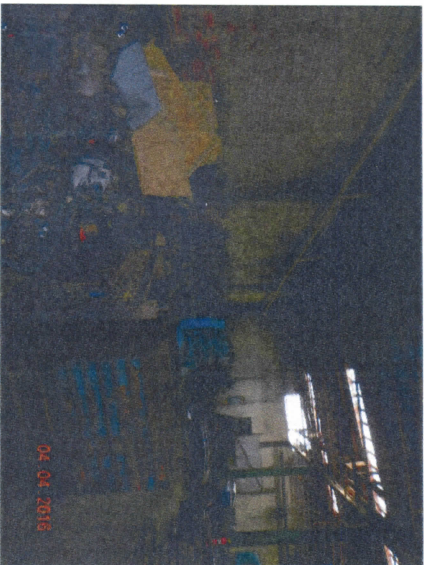
DSCN6982

At the time of the inspection, there were oil stains on the ground as seen in photos DSCN6982, DSCN6984, DSCN6988. There were additional locations where oil had spilled or leaked and speedy-dry was used as seen in photos DSCN6986, DSCN6989.

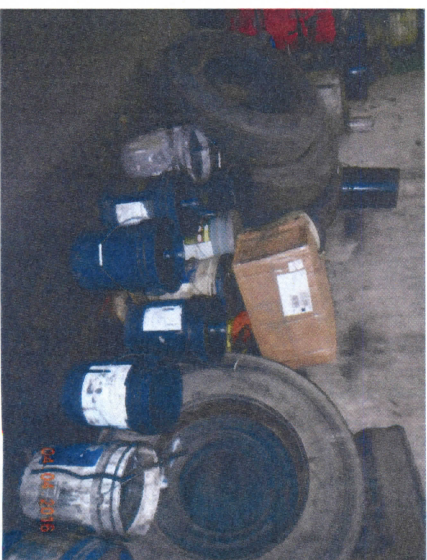
DSCN6985

1. At the time of the inspection EPA inspectors observed a dumpster on the site that was uncovered and exposed to stormwater as seen in photos DSCN6995, DSCN6997, DSCN6998.
2. At the time of the inspection EPA inspectors observed open oil containers in the storage area as seen in photo DSCN6985.
3. At the time of the inspection EPA inspectors observed rusty metal parts and scrap materials on the property and exposed to stormwater as seen in photo DSCN7000.

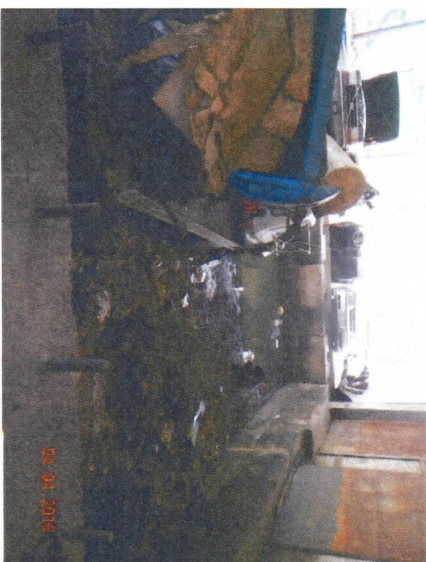
DSCN6994

At the time of the inspection there was standing water in the loading dock area. This water had an oily sheen on the surface. There was a large sediment collection in the loading dock area.

As required in part IV.C.9.a. of the permit, all impervious surfaces and bermed areas shall be regularly maintained and kept free of fluids. At the time of the inspection, there was a collection of water and sediment in the loading dock area in the rear of the facility with an oily sheen on the surface therefore in violation of part IV.C.9.a. of the permit as seen in photos DSCN6994, DSCN6996, DSCN6997.

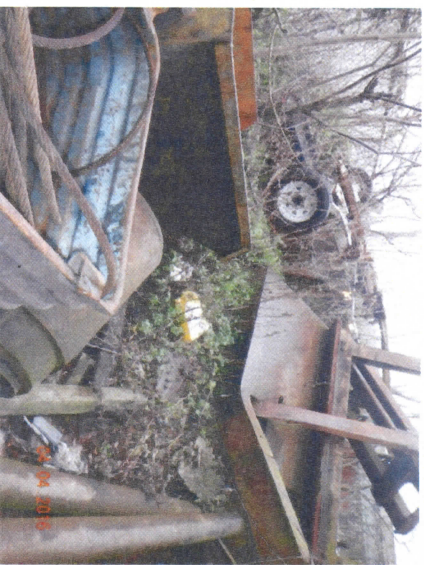
DSCN7000

At the time of the inspection, there was uncontained rusty scrap metal and parts in the back of the property as seen in photo DSCN7000.
